Home Court ADVANTAGE

Teamwork was the key to a high-speed roof replacement at Clemson University's Littlejohn Coliseum.

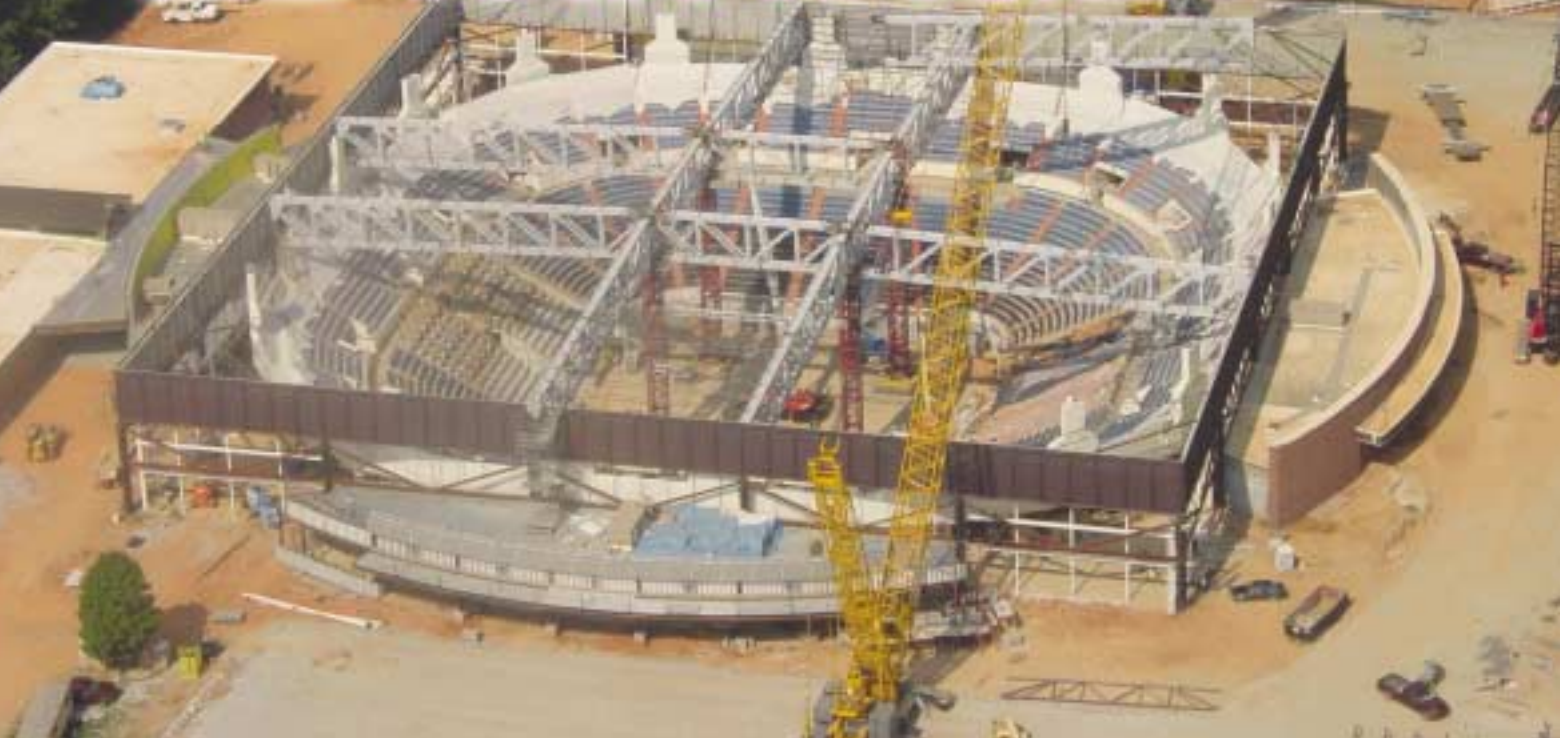
Opposite page: An aerial view of the last of the 120' truss sections being put in place.

Next, the 120'-span trusses were set between the exterior and the box. The corners were then filled in with the intersecting joist girders. The joist bays were then set as 60' panels and the structure was decked with 3" Type "N" Non-Cellular Acoustical Deck.

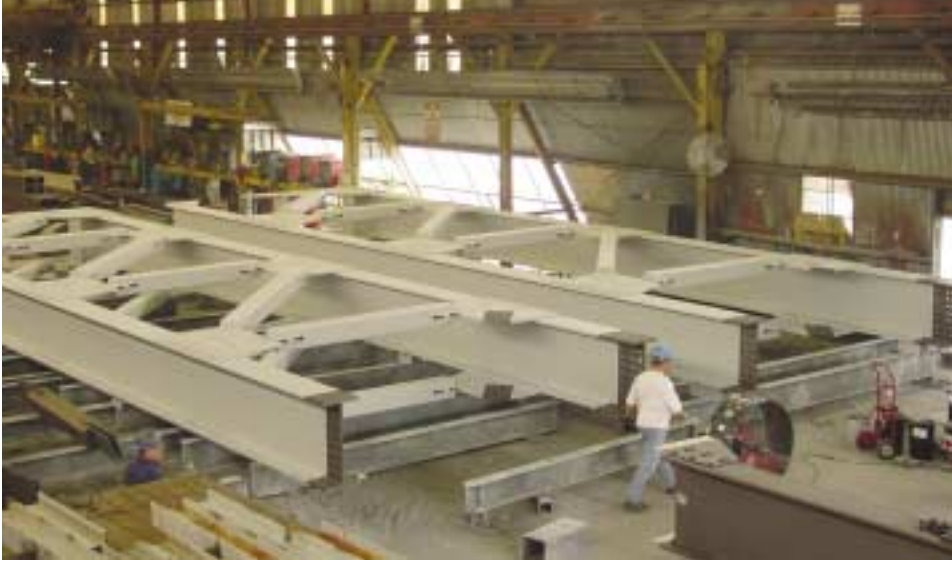
Left: View of the 60' truss sections in the shop after assembly and painting. The ends are unpainted for the slip-critical bolted field splice.

SC Steel, C.P. Buckner, Geiger Engineers, and HOK/Keeshen worked together to create the final design. The roof structure is 300' by 300' with 60' square bays. Geiger suggested a concept that would use four main 300' long by 14'-deep (center-to-center of chords) trusses at the two most interior column lines in each direction, forming a “tic-tac-toe” shape at the center. It was decided that the perimeter plate girders and columns could be left intact, with new trusses framed into them. The design concept chosen for the trusses was similar to some that Geiger had designed for another arena. They are constructed using W36×210 through W36×300 top and bottom chords, with the web oriented horizontally. The web members are pairs of 8"- and 10"-square HSS members connected to the flanges of the W36s. The trusses were shop assembled (bolted) into 60' sections for delivery. The trusses double as

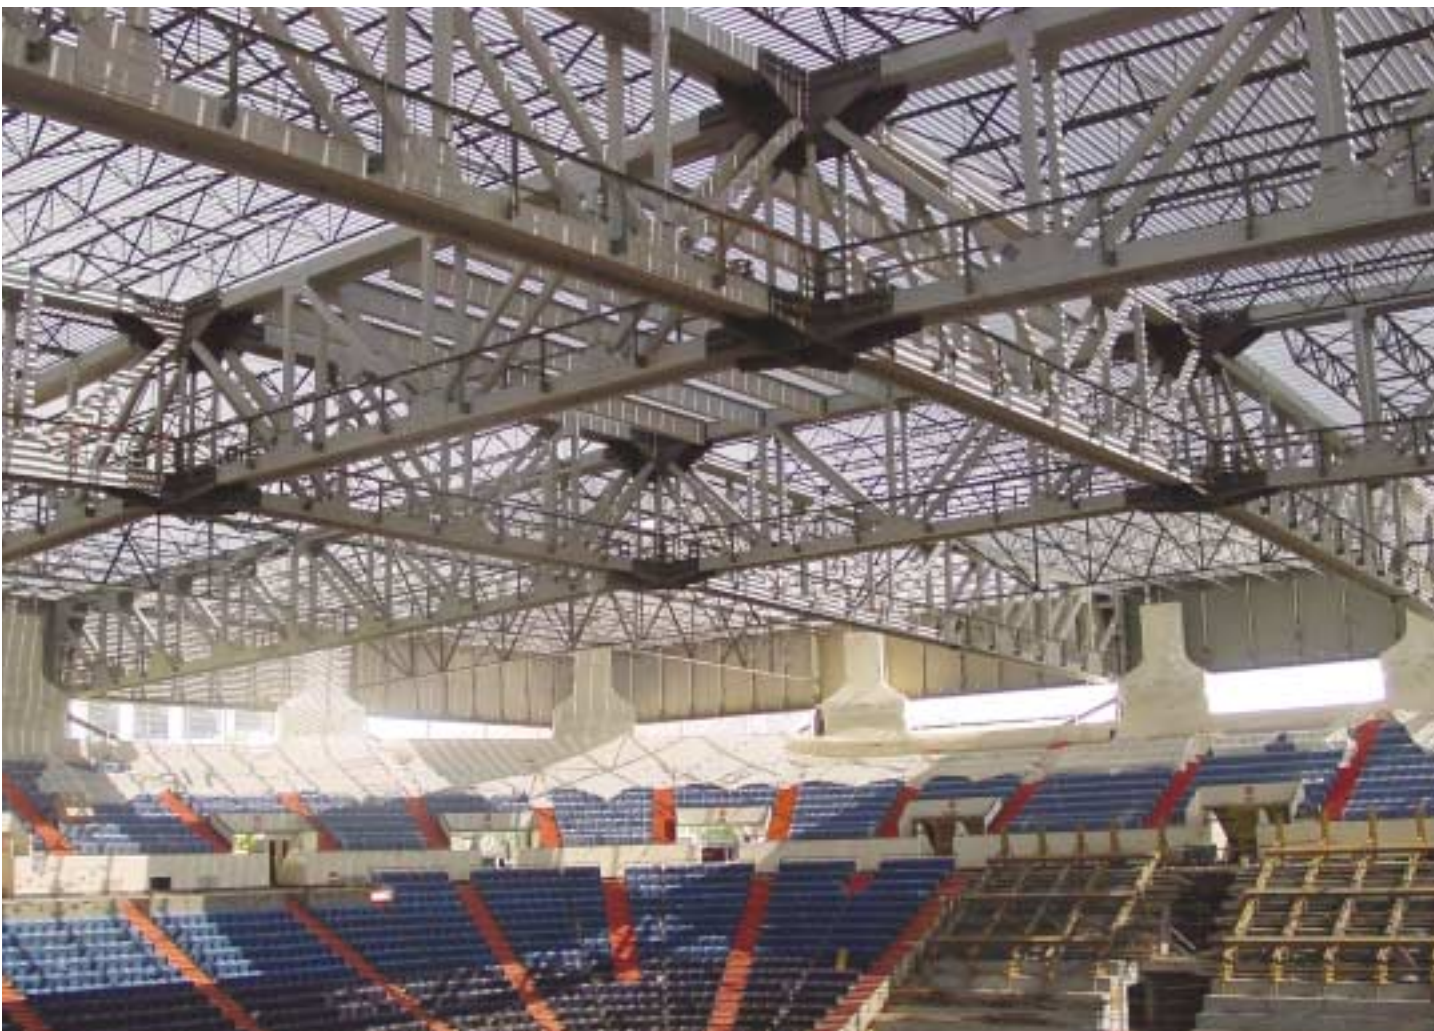
Below: View from inside the arena looking up after the roof deck was installed. Note the "built-in" catwalk system. The joists are oriented in perpendicular directions in adjacent bays.

The main trusses along with the joist girders in the corners formed 60' by 60' bays, which were filled in using 60' span joists at 7'-6" on center. The joists in adjacent bays were placed 90 degrees to each other, forming a checkered board pattern, and evenly distributing the roof load to the perimeter of the building.

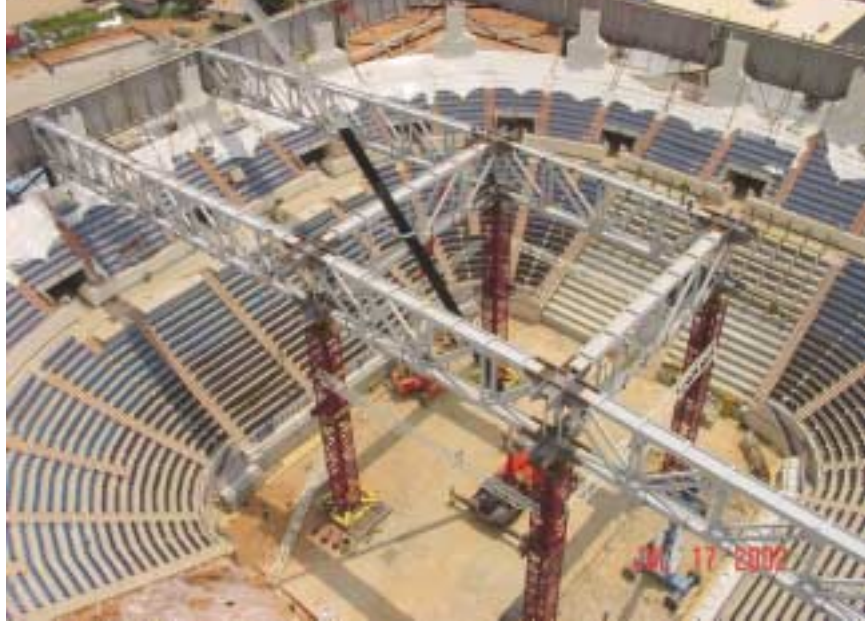
Overhead view of the main trusses during the erection stage. The four shoring towers were used both during demolition and erection.

The roof was removed by lifting the entire 60' bay (approx. 90,000 lb) at once, including existing joists, roof slab, and roofing. Four shoring towers were installed at the corners of the center 60' bay, and the existing exterior plate girder was temporarily braced back to the seating bowl. The girders were then removed in 60' and 120' sections. Lifts were made at a radius up to 260'.

The new structure was put into place similar to the removal of the old. Using four shoring towers, the four

center 60' truss sections were set on the towers to form a box.

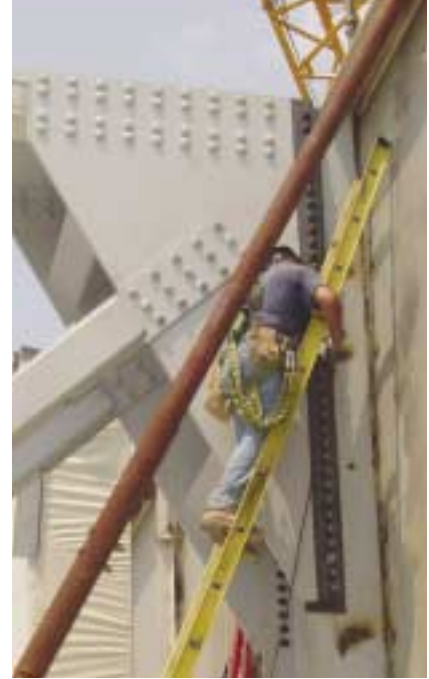
One of the end connections of the main (new) trusses to the exterior plate girder (existing). In the foreground, adjustable pipe braces stabilize the existing perimeter plate girder.
